**PEDESTRIAN HEART
DARLINGTON**

ROAD SAFETY ASSESSMENT REPORT

Pedestrian Heart Darlington

Road Safety Assessment

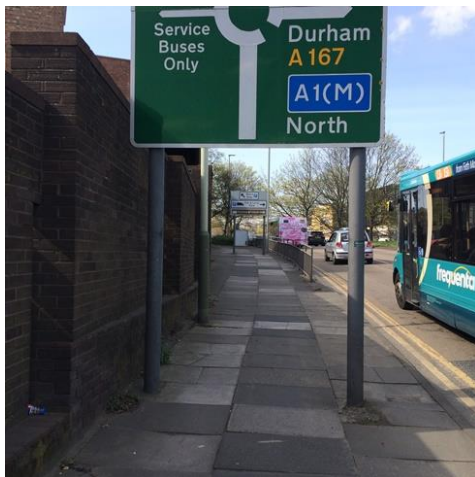
A1.4 Issue

Summary: Existing street furniture may increase the risk of pedal cycle collisions occurring.

Description: To facilitate the prohibition of pedal cyclists accessing the town Centre the existing footway around the town centre will need to be altered to accommodate pedal cyclists. However this will also require existing street furniture such as signs to be moved to allow cyclists to use safely. Failure to move the street furniture may increase the risk of pedal cycle collisions.

Recommendation: Ensure all signs and street furniture are positioned to accommodate both pedestrians and pedal cyclists around the perimeter of the town centre.

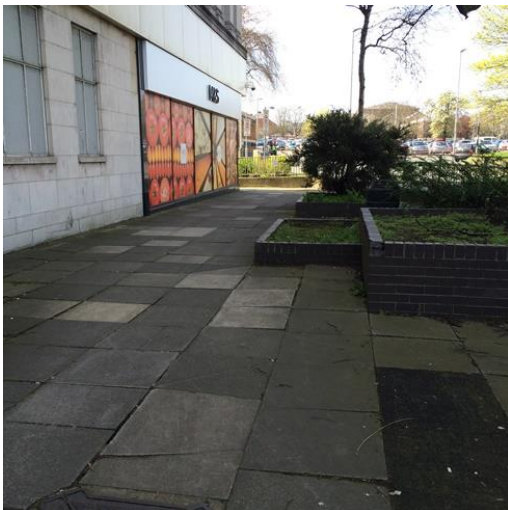
A1.6 Issue

Summary: Lack of forward visibility may increase the risk of pedestrian/pedal cycle collisions occurring.

Description: The proposed off carriageway cycle route will involve negotiating a severe turn when approaching Northgate from both the east and west. Due to the existing building line there is limited forward visibility. There is an increased risk of pedestrian/pedal cycle conflict.

Recommendation: Provide cyclists dismount signs on both approaches to Northgate or provide an alternative layout which improves visibility on this corner.

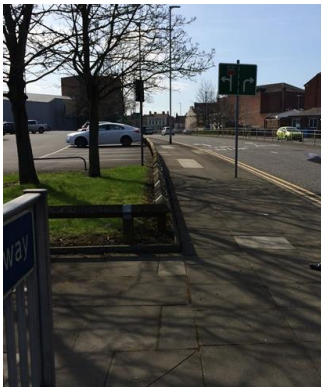
A1.10 Issue

Summary: Compact radius of bend may increase the risk of pedestrian/pedal cycle conflict.

Description: The proposed off carriageway cycle route involves negotiating a severe turn. There is concern that cyclists may lose control and increase the risk of pedestrian/pedal cycle conflict.

Recommendation: Relax the radius of the bend.

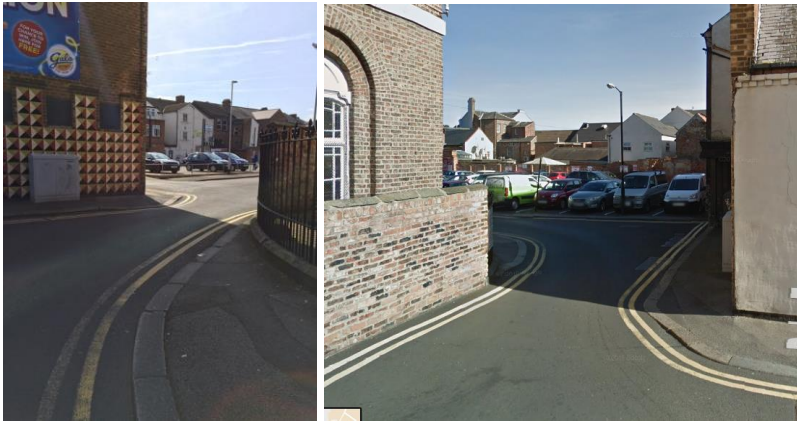
A1.12 Issue

Summary: Pinch point and limited forward visibility may increase the risk of pedal cycle collisions.

Description: The route proposes to guide pedal cyclists along Salt Yard which is currently one way (northbound). Salt Yard links onto Winston Street and Raby Terrace via a narrow link. The limited road width and forward visibility is likely to result in an increase in pedal cycle collisions occurring.

Recommendation: Prohibit motorised vehicles accessing Salt Yard from Winston Street/Raby Terrace. Widen the junction at A68/Salt Yard and allow two way movements on Salt Yard.

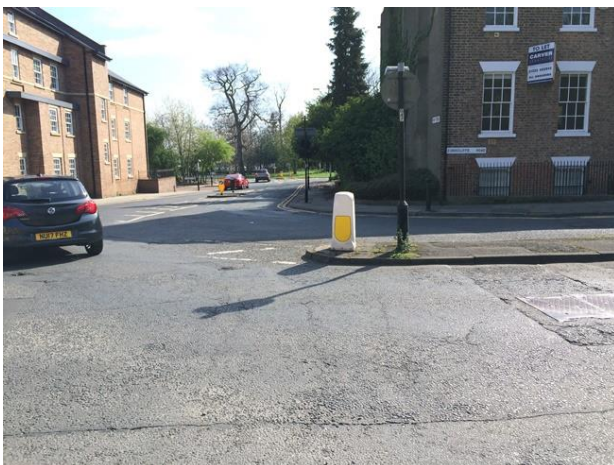
A1.13 Issue

Summary: Lack of crossing facilities for cyclists may increase the risk of collisions occurring.

Description: The proposed safe route links between Coniscliffe Road and Larchfield Street. However there is no safe crossing point for cyclists to access Larchfield Street when travelling northbound along Coniscliffe Road from the outer radial routes coming from Blackwell. The lack of safe crossing facilities may increase the risk of pedal cycle collisions.

Recommendation: Provide a protected right turn for pedal cyclists at this location.

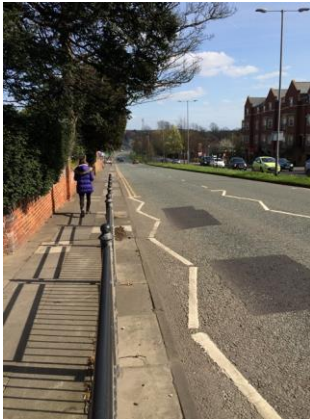
A1.16 Issue

Summary: Limited width of existing footway may increase pedestrian/pedal cycle conflict.

Description: The proposed off carriageway route will travel adjacent to the A167. However the existing footway appears to be narrow along this section. The limited width is likely to increase the risk of conflict between pedestrians and pedal cyclists.

Recommendation: Provide a shared area to accommodate both pedestrians and cyclists along this section of the A167.
